# PHENIX WEEKLY PLANNING

8/5/2010  
Don Lynch

# 2010 Shutdown (Overview)

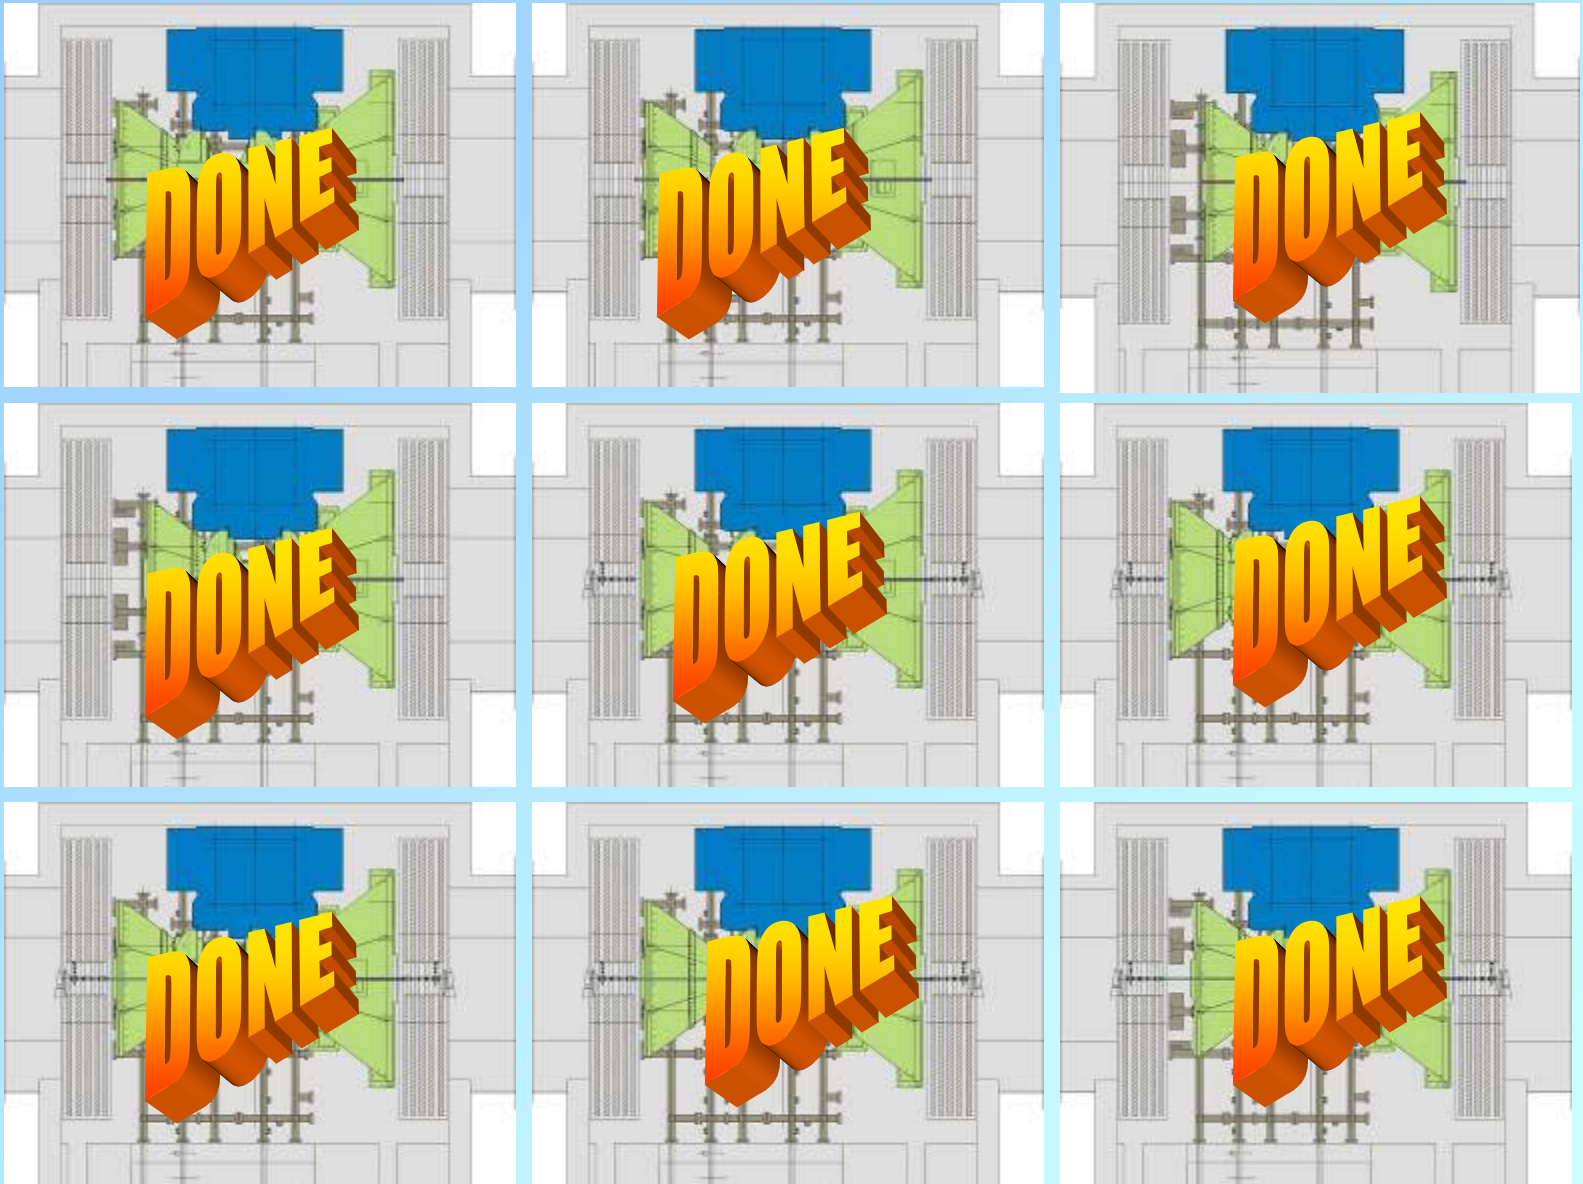
# Removal of Existing Beampipe

Beampipe Removal is complete at this step

## Beampipe De-installation

<u>Task</u>	<u>Due By</u>	<u>NOTES</u>
Move old Be bp south into MMS and move CM north	Done	PHENIX Techs →
Move MMS to shutdown park position	Done	PHENIX Techs →
Remove old Be BP	Done	PHENIX Techs →
Move CM south and east	In Progress	PHENIX Techs →
Remove north 3 to 5 transition	In Progress	PHENIX Techs →

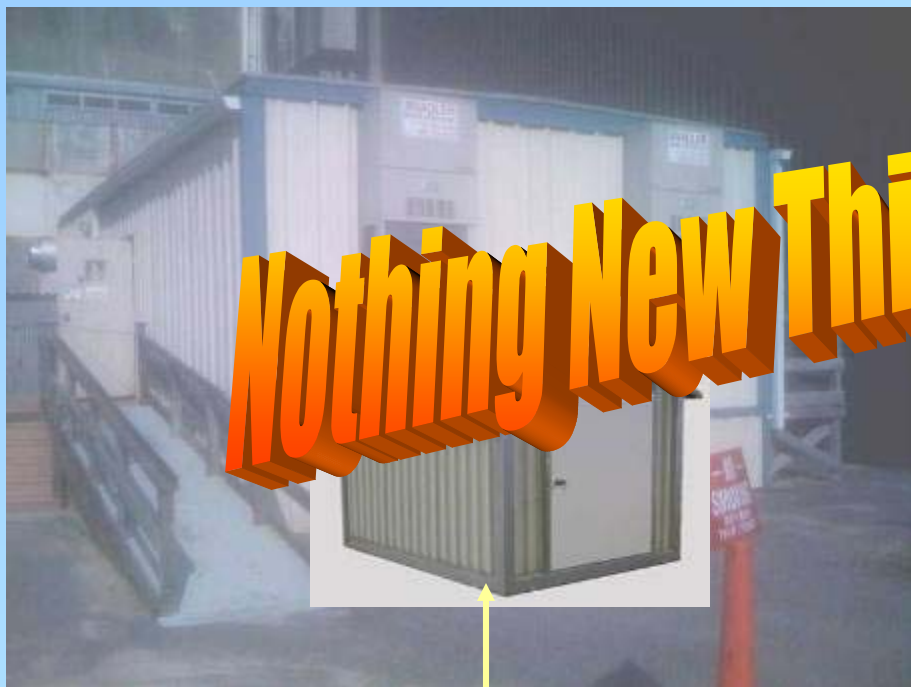
Proposed shed addition to  
Gas Mixing house

To be located in front of  
AC on east side of GMH

House/store  
for R134A to  
keep up with TOF West &  
RPC requirements. No  
flammable gas, standard  
shed with heat. Barn style  
doors desirable. Place on  
asphalt with no threshold to  
allow bottle management  
with pallet lifter.
